Alaskan retrofit roofing project meets many challenges

Retrofitting the roof of an immense, A-frame style warehouse in Alaska last fall proved to be an interesting project for all involved. The job had many challenges – difficult weather conditions, an extreme slope to the roof, some deterioration on the roof and a short time frame for completion.

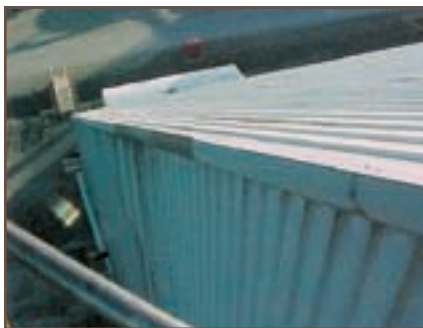
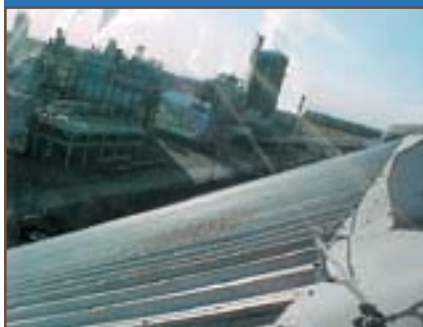
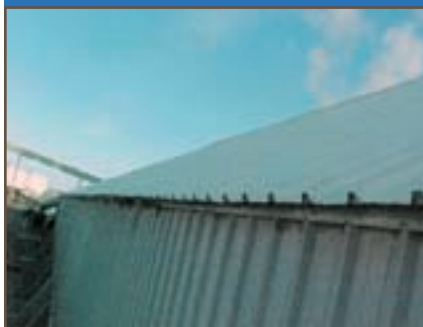
PRECONSTRUCTION

The roof on this warehouse at the Agrium Kenai Nitrogen Operations in Kenai, Alaska is 190 wide 460 feet long with a 7:12 pitch that is 25 feet high at the eave and about 90 feet to the ridge.

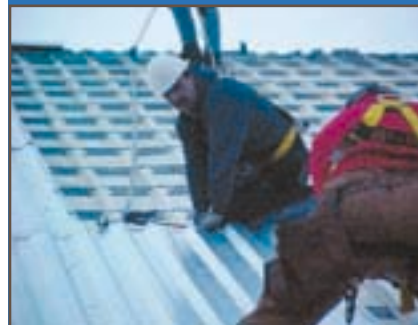
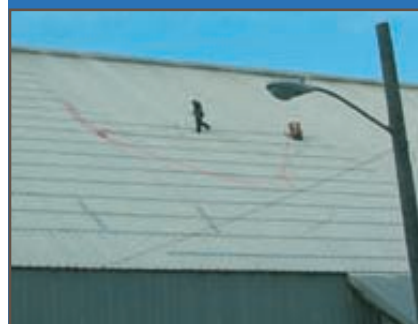
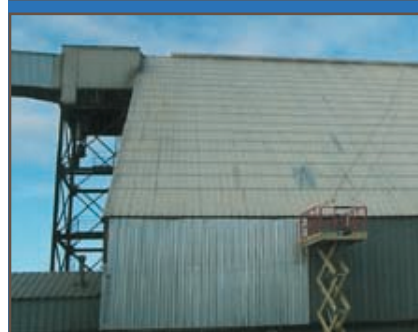
CONSTRUCTION

EMCO installed steel cables across and over the structure so its crew would have a 100 percent tie off at all times while retrofitting the facility. They installed a Y-36 system from Morin Corporation that features a 24-gauge Galvalume panel that is 1.5" deep and 36" wide.

The Roof Hugger systems is installed before the panel system and placed within 5' of each other and within 2.5' in the high wind areas. This set up was a big help as EMCO laborers maneuvered to install the 36" wide Galvalume panels.

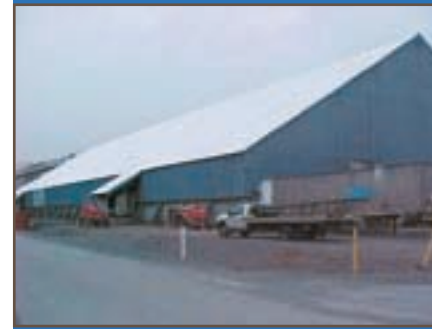
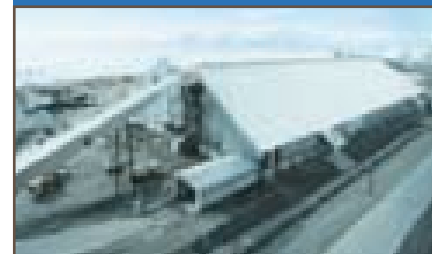
COMPLETION

The roof of the Agrium warehouse soars up like an A-frame to meet the angle of repose of the fertilizer materials stored inside it.
